State of Wyoming Corner Record

Corner Name West Quarter Corner Section 14, T 13 N, R 69 W, 6th P.M.

County: Laramie Wyoming

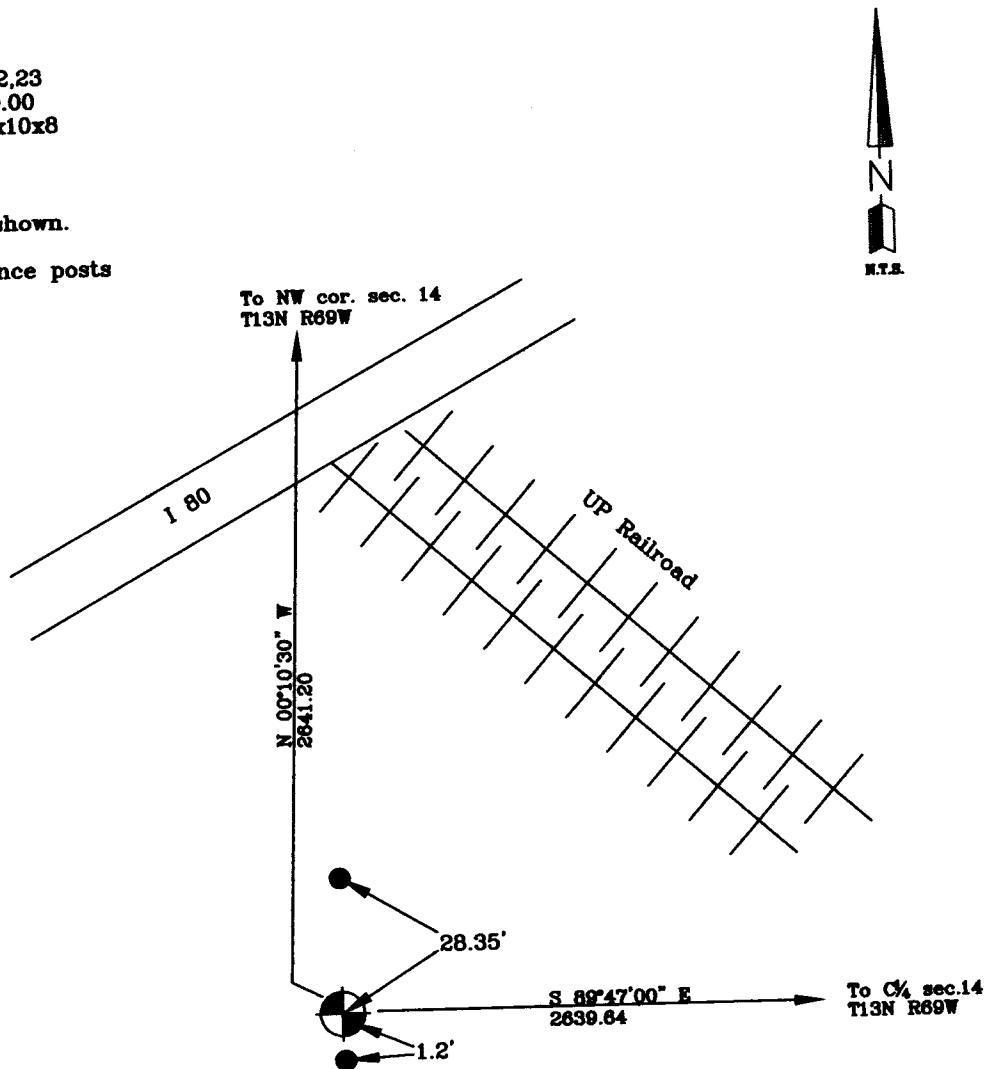
Found 3 1/4" Cap stamped as shown.

Set two PK nails into RR tie fence posts
as shown.

Approx. 1/3 Mile
south of I-80 and
RR intersection
