State of Wyoming Corner Record

Corner Name SECTION CORNER Section 13, T 14 N, R 61 W, 6th P.M.
County: LARAMIE Wyoming

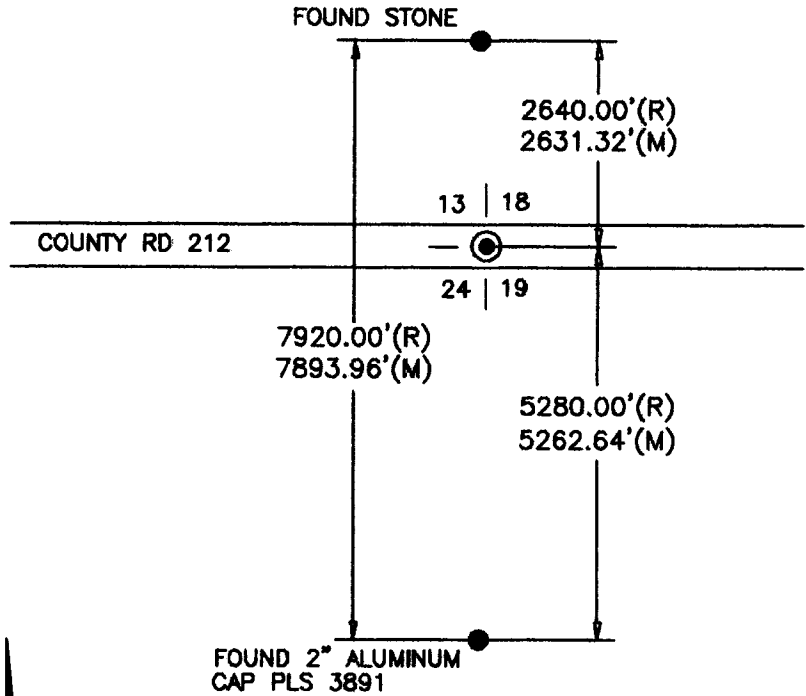
Reference Locations

REFERENCES: SURVEY TIES TO WEST QUARTER CORNER AND SOUTHEAST CORNER SECTION 24

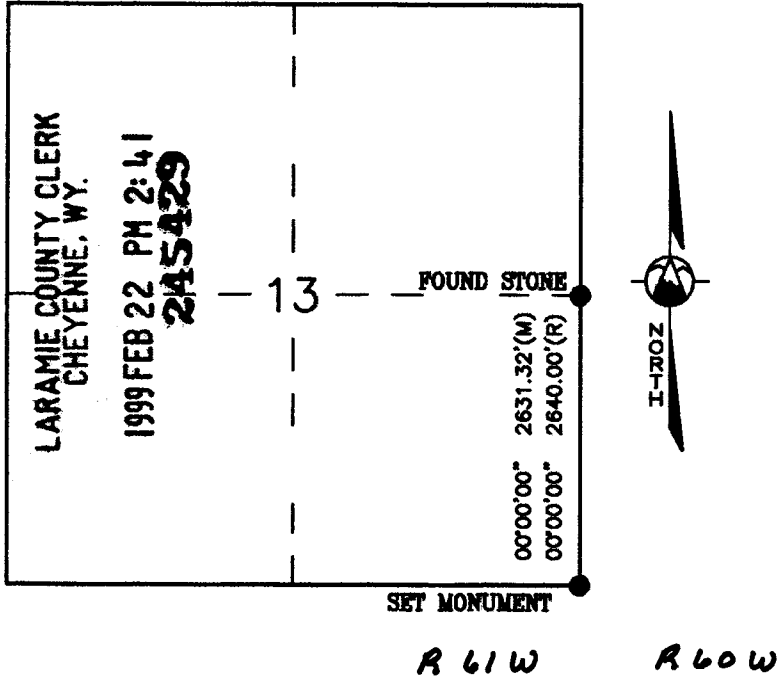
Monument Location

FOUND: NOTHING

GLO RECORD: SET SANDSTONE 20" X 13" X 5"

SET: BY SINGLE PROPORTION 24" X 5/8" DIA. REBAR WITH 3" ALUMINUM CAP STAMPED ACCORDINGLY, SEE MONUMENT INSCRIPTION SKETCH
