State of Wyoming Corner Record

Date of Field Work: November 15, 2013 Office Reference: Kaiser Francis Oil. Silo Field

Corner Name: SW Corner Section: 6 *↓*-T. 15 N., R. 63 W., 6th P.M. SBRPEPLS/PLSW: MARCH 1994/97 T. 15 N., R. 64 W., 6th P.M.

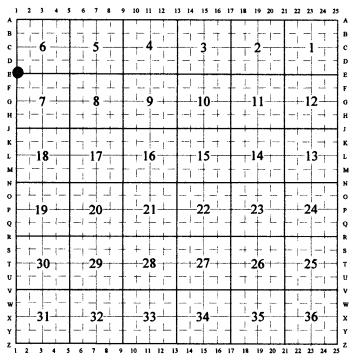
CROSS INDEX DIAGRAM

At the intersection of an old property bundary fence north and latitudinal center line of Laramie County Road No. 220, I set a no. 5 x 24 ins. rebar with 2 1/2 ins. diam. alum. cap, marked as noted below, 6 ins. below the graded county road.

The spike noted above bears south 2.5 ft. A 16d nail set in a fence corner post bears north 34.4 ft. A 16d nail set in a fence corner post bears southeast 47.8 ft.

The re-established northeast corner of Section 7, a 2 1/2 ins. diam. alum. cap, bears N89°27'E 5197.4 ft. The re-established southwest corner of Section 7, a 2 1/2 ins. diam. alum. cap, bears S0°15'W 5250.6 ft.
